David George Bird

ASSTEAD COMMON, SURREY (ENGLAND): ROMAN TILEWORKS

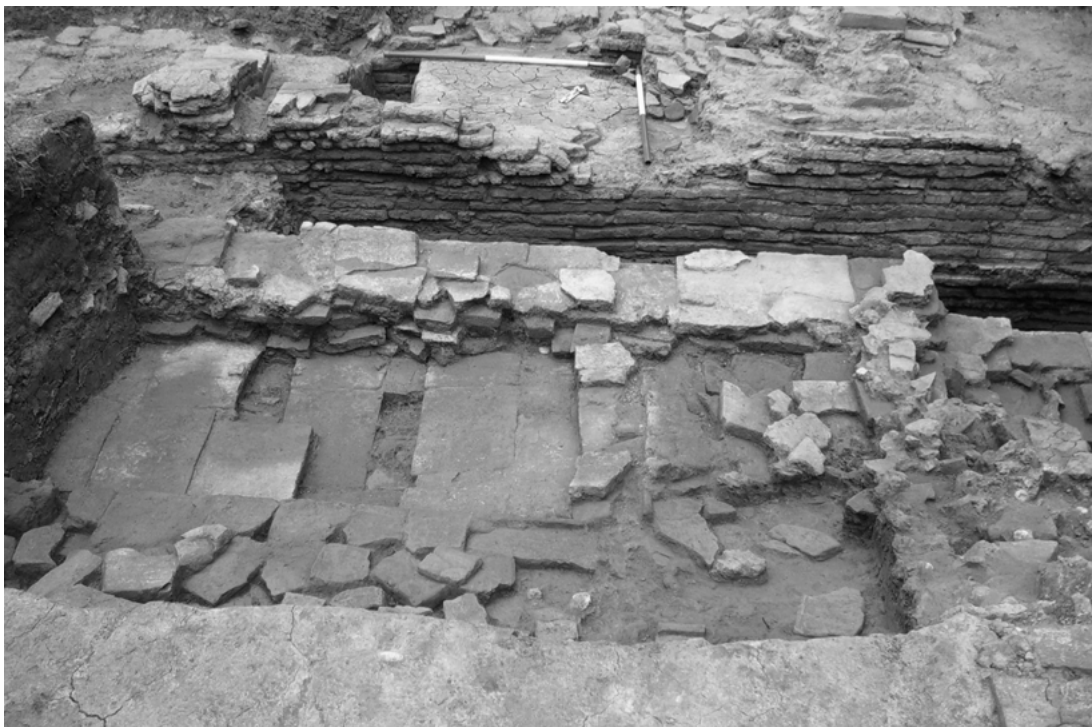
Fig. 3. Part of the kiln seen from the south. The scale poles lie mostly on the yellow clay fill over the northern side chamber of the first-period kiln. To the left of this can be seen the remnants of the later tiled base over the clay and parts of two of the second-period inclined flues. In the foreground the yellow clay fill has been removed from the southern side chamber revealing the filled-in remnants of the first-period inclined flues. The second-period central flue wall can be seen built over them. The front and side walls of the kiln are also visible (photograph: David Bird).

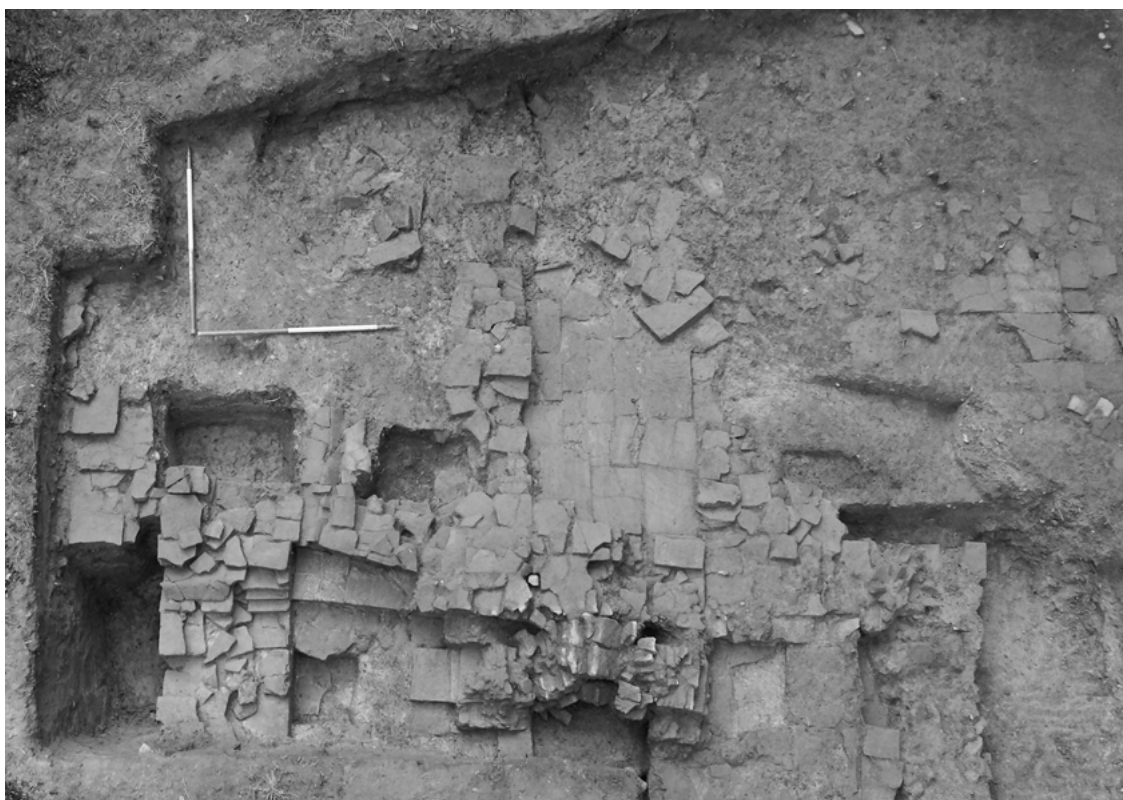
Fig. 5. Overhead view of the rear of the kiln, with west at the top. The collapsed flue arch is visible in the centre foreground at the end of the central flue, just inside the back wall of the kiln. The tiled approach to the kiln, with its two flanking walls, can be seen, continuing the line of the central flue. The line of *imbrices* laid through the wall can be seen at the south-west corner (photograph: Stella Fagg).

eight new inclined flues. Evidence for these side flues only survived towards the back of the kiln but the measurements indicate the likely number. Part of the collapsed arch that once carried the side flue wall nearest the back of the kiln over the central flue had survived (figs. 4–5).

A tiled approach was identified leading up to the back of the kiln and exactly continuing the line of the central flue (figs. 2; 5). It was probably associated with the earlier kiln and was presumably intended to facilitate loading and unloading. Only a few parallels have been noted so far but see for example Eccles (Kent) and Heiligenberg kiln 1.⁹ Groups of tiles were found laid flat near to the outside of each corner of the kiln. They varied considerably in number and the way they were laid but as none were noted elsewhere it is suggested that they served to support large posts for a cover structure. The variations could be explained by differential ground, the need to make up for some rotting of a post or the use of replacement posts. If such a structure existed it would probably have continued over the extended flue and stokehole, but this could not be tested by excavation as the relevant areas were not available.

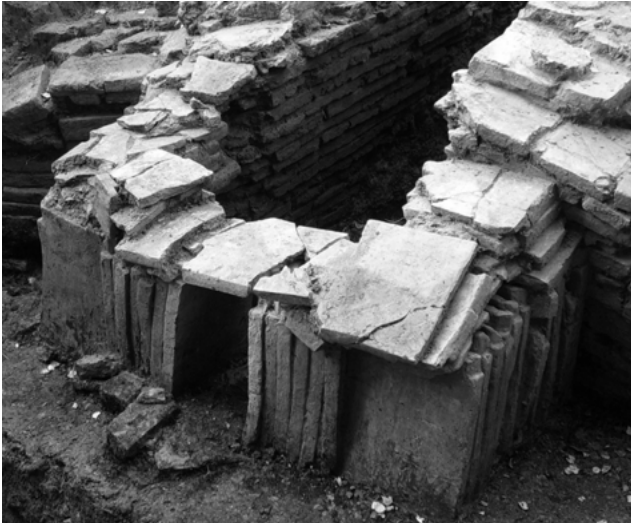
Fig. 6. Detailed view of the *tegula* structure, with the tile that bridged the central gap restored to its original position (photograph: David Bird).

A structure at the stokehole end of the first-period central flue probably survived because of the raising of the kiln; it was below the level of the base of the second-period central flue. The first flue had been closed by *tegulae* placed on end (with their cut-outs at the top) to continue the line of the flue walls into the stokehole (figs. 6–7). There were 10 on the south side and 11 on the north and then others had been placed between them, leaving a small central gap, with seven *tegulae* to the south and six to the north. The central gap had been bridged by a horizontal tile. Part of this tile had collapsed into the gap but its broken edges could be matched exactly with other fragments still *in situ* on each side. There were other tiles laid horizontally in a rough pattern around the top of the *tegula* structure but it is not clear how the extension was covered beyond the permanent flue arch as it did not survive high enough. It is assumed that the structure was intended to

The central gap in the block was presumably controlled using a cover, perhaps another *tegula*,¹¹ to make it possible to judge the state of the fire and to permit more or less air to enter the kiln.¹² No close parallels for the *tegula* structure are known to the author¹³ but a tile kiln at Hartfield in Sussex, close to the Surrey border, had a vertical stack of *tegulae* on one side of the flue arch. David Rudling postulated that they might have been part of a structure for closing the flue¹⁴ and it could well be that the Ashted example shows how this would have been done. No doubt close analysis of other kilns will provide examples of features more damaged than

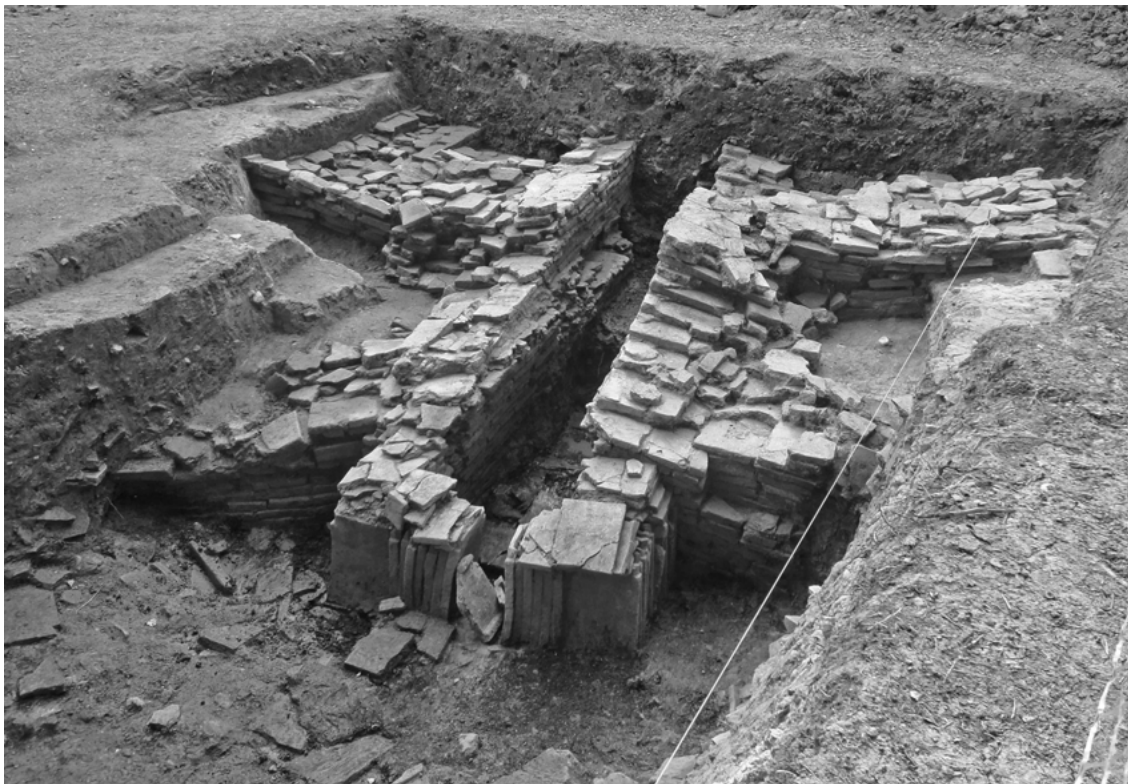
Fig. 7. The front of the kiln seen from the east. The *tegula* structure is in the foreground, butting up against the front of the central flue and the two wing walls that delimit the front of the stokehole. A prominent ledge along the left side of the central flue marks the join between the first- and second-period walls. The kiln's front walls can be seen in the background, and a small part of the kiln proper (photograph: Stella Fagg).

The first-period kiln was eventually demolished to about the level of the springing of the arches across the central flue and a new kiln was raised on top. New side walls for the central flue were built up from tile fragments set on a thin layer of clay on the base provided by the earlier walls, with a straight edge along the side of the flue but only a rough edge on the other side (fig. 3). There was an obvious join and a ledge in places along the central flue (figs. 4; 7), which seems to have been backfilled with burnt clay and broken

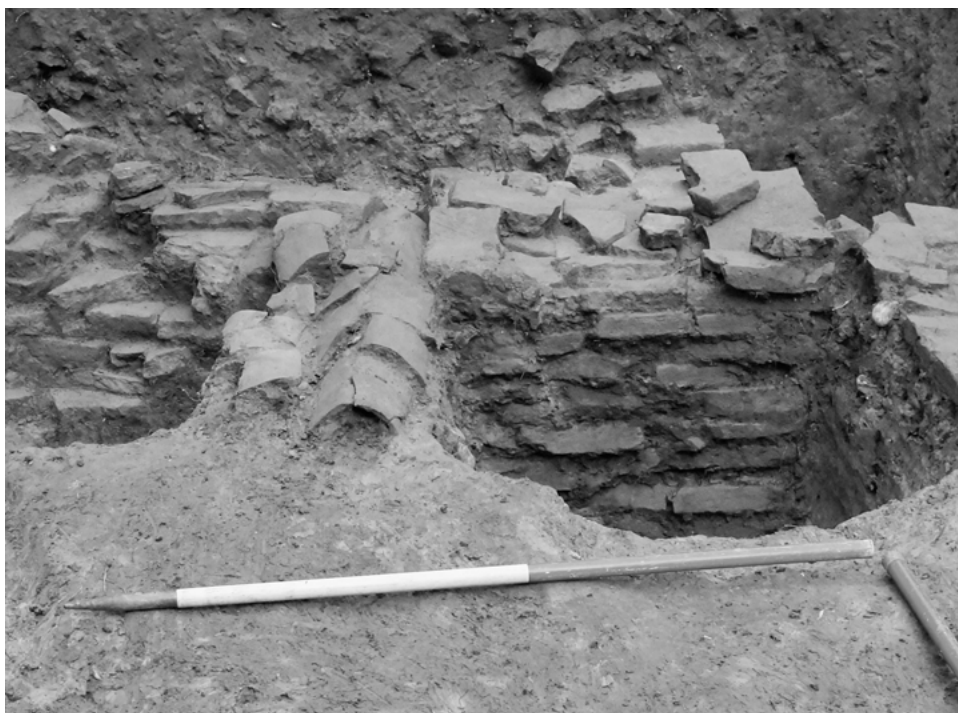
Fig. 8. Detail of the line of *imbrices* laid through the back corner of the kiln, seen from outside the kiln (photograph: Stella Fagg).

Another aspect of airflow control was also found at Ashtead. At one of the back corners of the kiln a line of *imbrices*, burnt on the inside, was found laid through the wall (**figs. 2; 8**). It is probable that there was once a similar structure at the opposite corner but that did not survive to a sufficiently high level. The aim must have been to provide small vents to draw the fire right through the kiln to its very back corners. It is probable that the vents were just above the top of the floor level of the first-period kiln, to judge by the angle of the surviving inclined side flues.

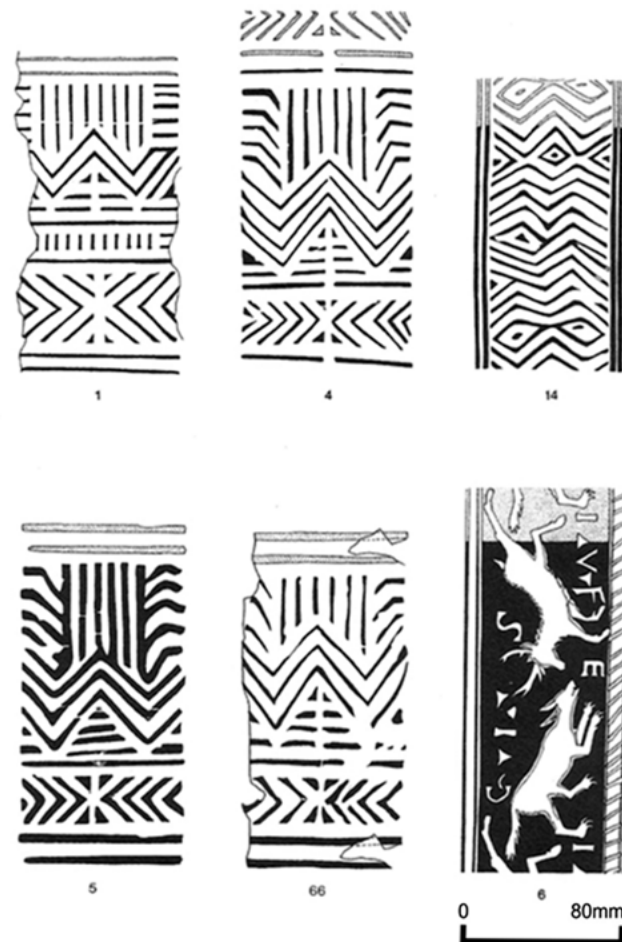
Fig. 9. The six die patterns used on box flue tiles made at Ashtead. Each tile required more than one pass with the roller (see the effect on the box tile shown on **fig. 10** for example). After BETTS ET AL. 1994, *passim* (illustration: Alan Hall and David Bird).

The overall site has a great many fragments of box tiles patterned by combing or by the use of a roller stamp. The latter technique is mostly confined to SE England.¹⁵ Six patterns are known to have been made at Ashtead, one (die 6) with well-produced lettering with serifs and stops around a finely-realised dog and a stag (**fig. 9**). The letters are usually interpreted as G(aius) I(ulius) S(...) and I(ulius) V(...) FE(cit). A. W. G. Lowther, the original excavator, made a study of the relief patterns used in Roman Britain, which was updated in 1994.¹⁶ It remains difficult to provide close dating for these patterns but the majority are thought to be of the 2nd century.
