NEW DISCOVERIES AT YEAVINGING, NORTHUMBERLAND

By ROGER MIKET,¹ SARAH SEMPLE,² TUDOR SKINNER³ and BRIAN
BUCHANAN⁴

Introduction

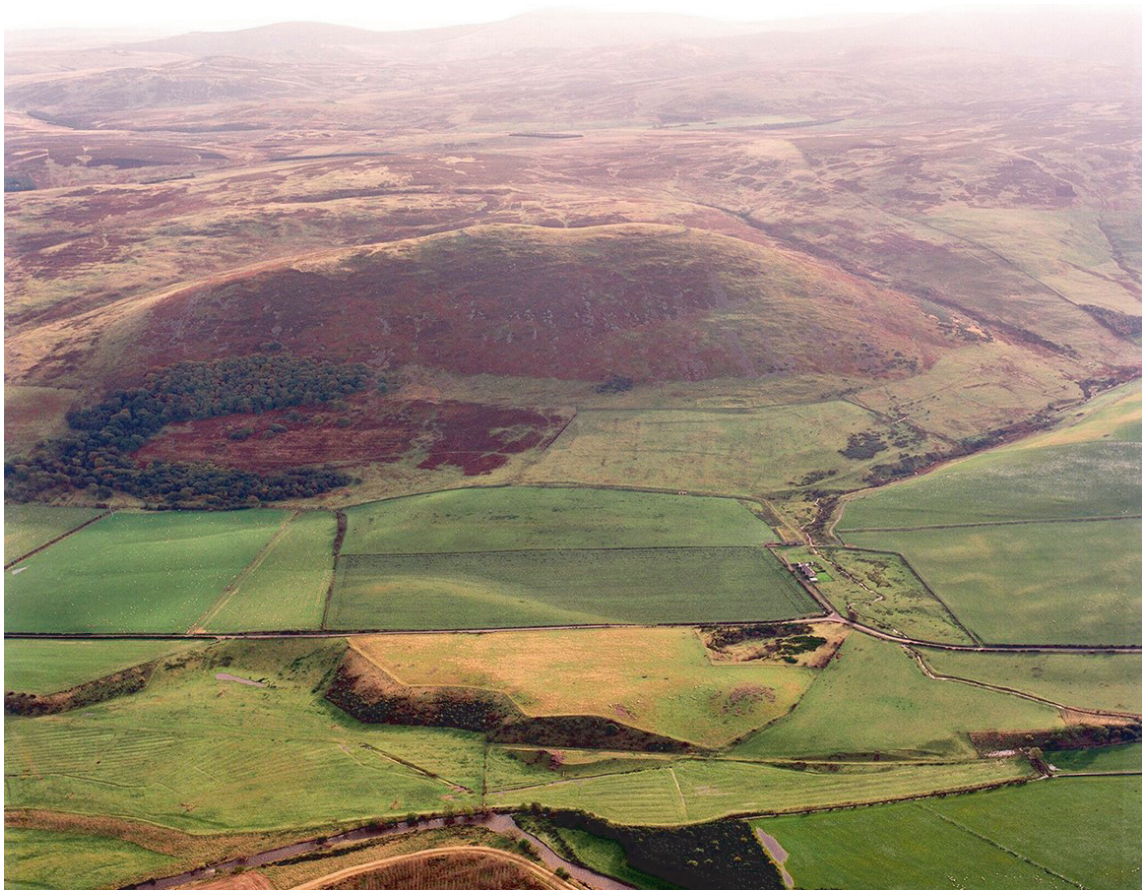
Figure 1a The gravel terrace in the lower central foreground is the location of both cropmarks and the later excavated evidence for an early medieval royal palace complex. © Airphotos Ltd.

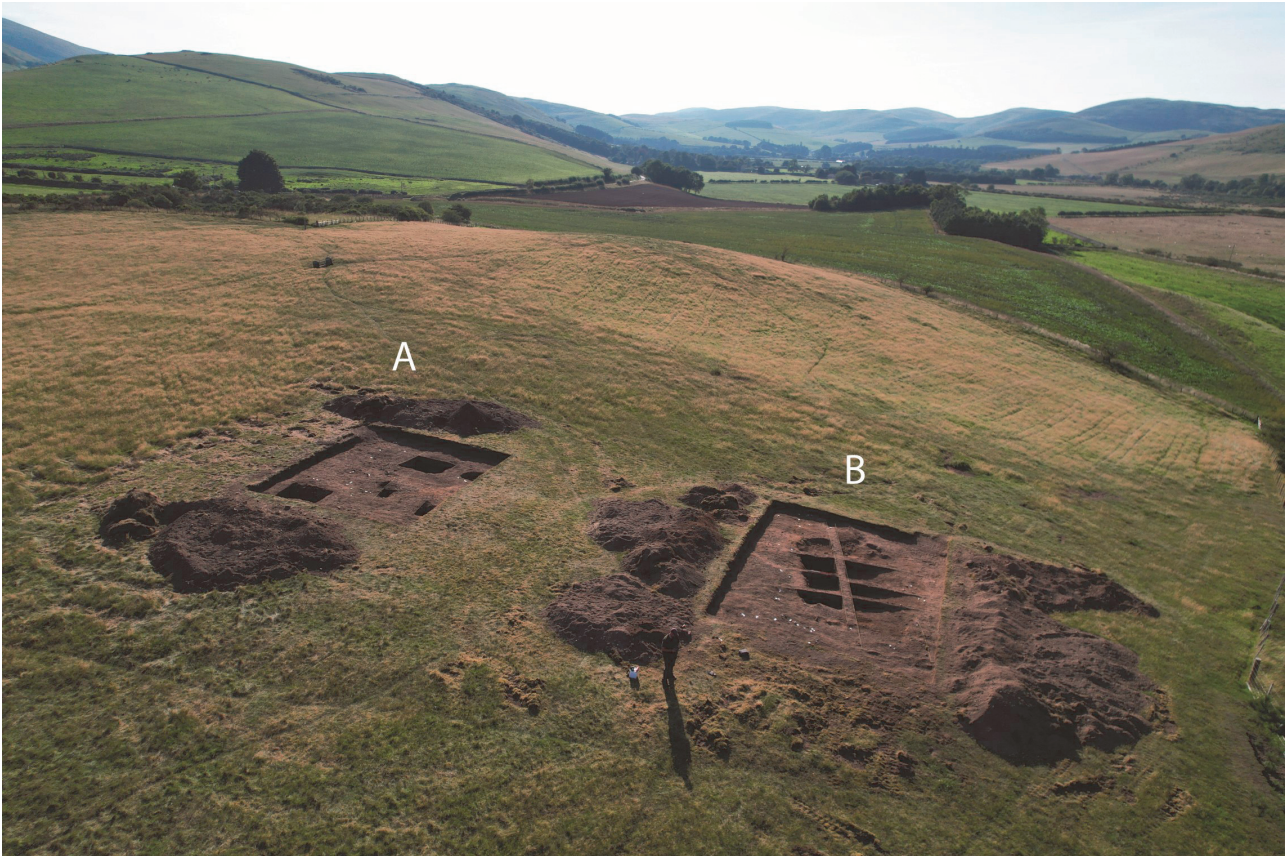
Figure 2 Aerial photograph showing the 2021 excavations underway with Trench A to the left and Trench B to the right. © Durham University and The Gefrin Trust.

With this in mind, in 2021, two trenches were opened in Hope-Taylor’s Area C (Trenches A and B) (Fig. 2). Trench A was positioned to relocate Hope-Taylor’s excavation of Building C1, which original site photographs had indicated contained substantial carbonised timber remains. Trench B was located to the north, to explore a sub-rectangular anomaly present on aerial photographs.

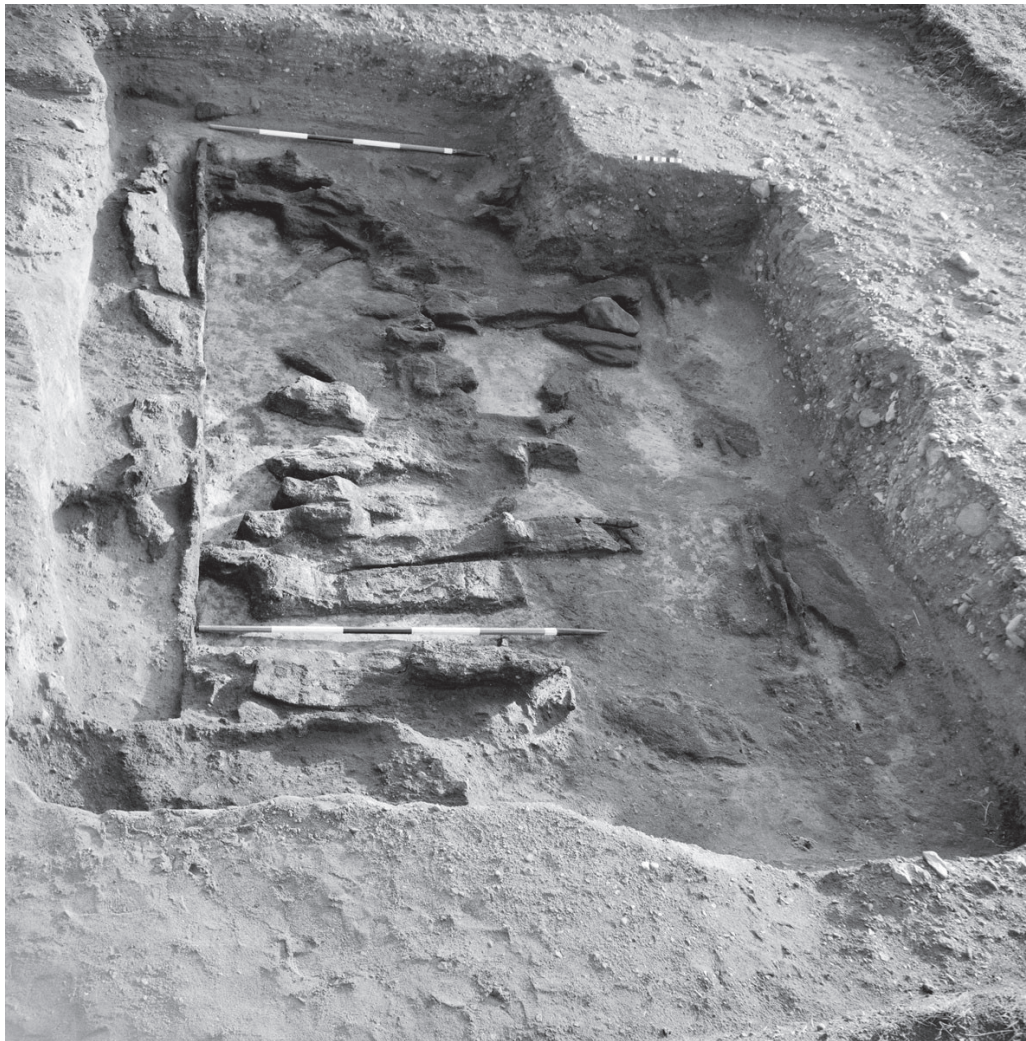
Figure 4b Hope-Taylor's photograph of the interior of C1 in 1956. The position of individual upright rectangular posts are visible within their bedding slot, cut at the foot of the pit sides in lower right in the photograph. Reproduced with permission from Historic Scotland Archive [Y56 91 5591].

of 'wear and patching' of the floor, 'along a line roughly 18 inches (0.45 m) from and parallel to the long axis' (Fig. 4b).

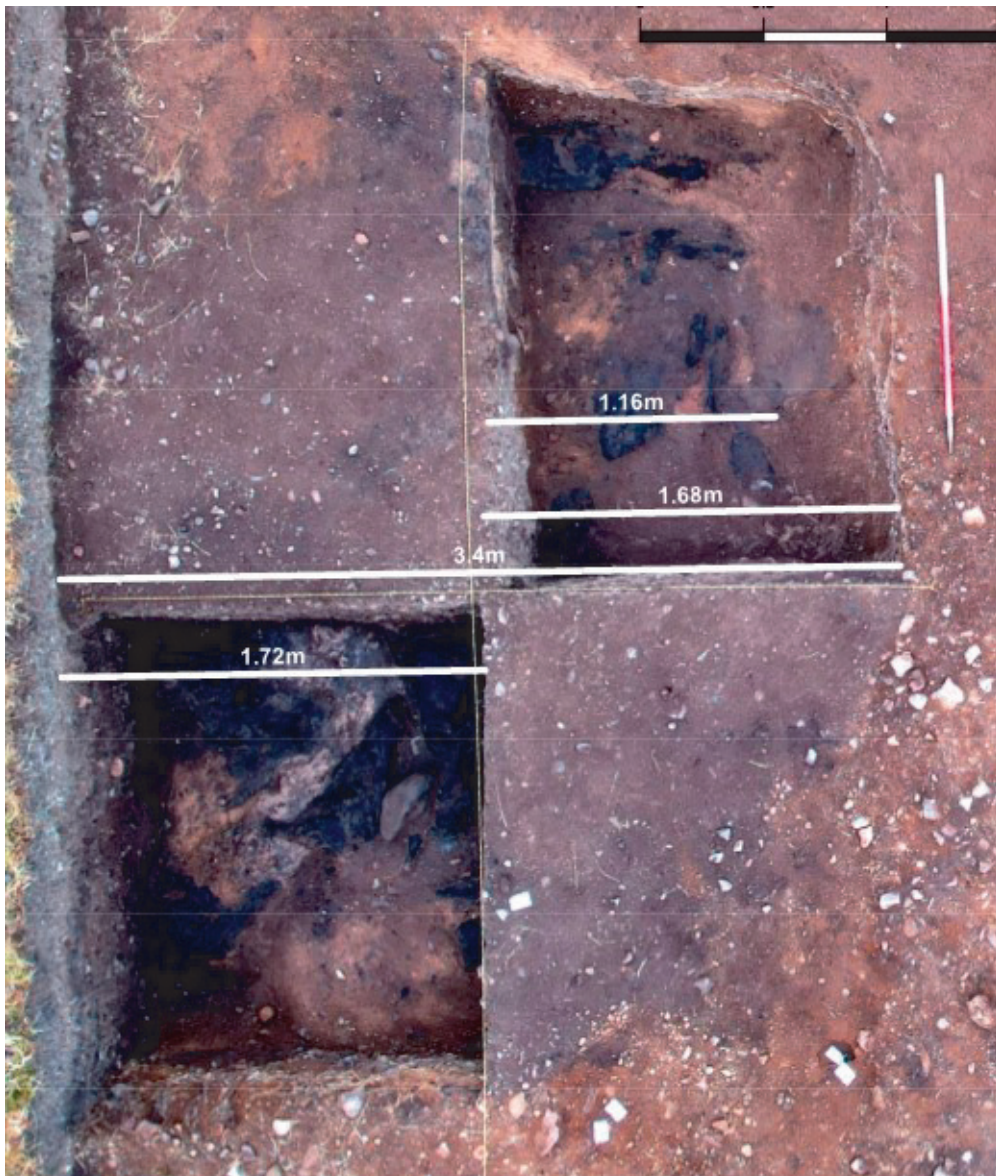
Figure 5 The quadrants excavated in the eastern half of Building C1. Note the spread of charcoal-debris at the lower left corner of the south-west quadrant, coincident with position of a stepped descent from the porch entrance. North at the top. Drone photograph by Brian Buchanan. © East Washington University and The Gefrin Trust.

Re-excavation in 2021 of Building C1 showed that much of the evidence upon which Hope-Taylor's reconstruction was based had survived to varying degrees within the interior (Fig. 5). This new work allowed for minor details and additional measurements to be added to those previously recorded, and – crucially – resulted in the recovery of datable material and environmental samples. One unanticipated outcome, however, was the discovery of an additional feature, which raises questions over the accuracy of Hope-Taylor's reconstruction.

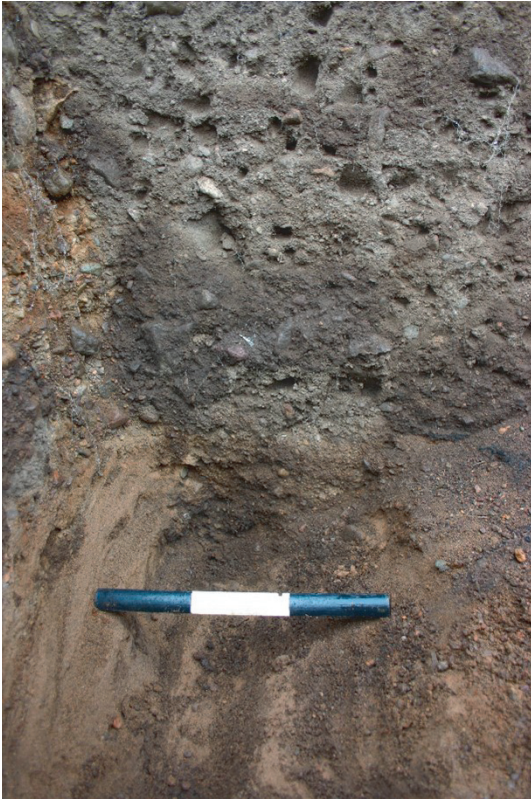
Figure 6 The south-western quadrant of C1 in 2021, from the east. The grey sand slot is visible running east/west tight against the foot of the cut (left), with the post-pit midway in its length. Photograph by R. Miket © Durham University and The Gefrin Trust.

preserved, notably along the line of the south wall, this space was filled with a grey sand, sealed beneath charcoal and debris deposits (Fig. 6). These deposits partially directly overlay the substrate upon which the horizontal planks rested, but also appear to have continued further downwards, filling a square-sectioned slot cut into this substrate and running parallel to the side walls of the pit. The section lying within the south-west quadrant was excavated in its entirety in 2021, to reveal a slot cut some 0.10–0.15 m in width and depth, running unbroken the full length of the excavated area. A single post-pit lay within its line, 0.15–0.18 m in diameter and filled with the same dark grey sand as the slot (Fig. 7). The position of this post-pit corresponds to those Hope-Taylor had identified elsewhere as ‘retaining posts’, and it is assumed to be a further addition to this group. The grey sand filling was not continuous throughout the length of this cut feature but terminated c. 0.3 m from the western section within the excavated quadrant (Fig. 7). Here, a darker filling containing some charcoal replaced the grey sand. This not only filled the slot but also spread further northwards to the edge of the clay floor of the interior.

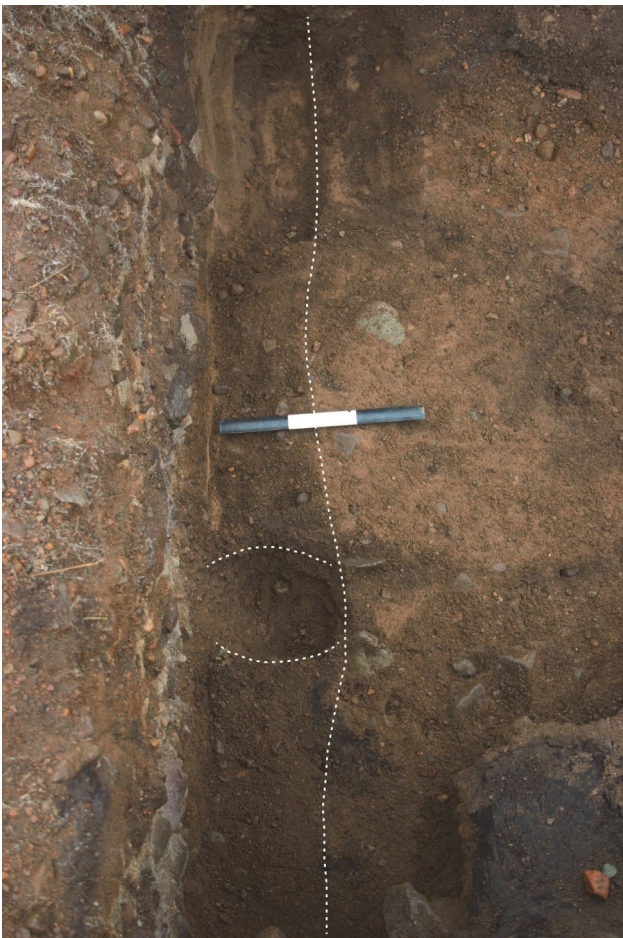
Figure 7 East-facing section of the timber slot, revealing fragmentary charcoal near its base, overlain by grey sand and a darker silt fill. Photograph by R. Miket © Durham University and The Gefrin Trust.
